| REPORT DOCUMENTATION PAGE | | READ INSTRUCTIONS BEFORE COMPLETING FORM |
|--|---|---|
| 4. TITLE (and Subtitle) STRESS CORROSION CRACKING OF A723 STEEL PRESSURE VESSELS: TWO CASE STUDIES | | 5. TYPE OF REPORT & PERIOD COVERED Final |
| 7. AUTHOR(s) J. H. Underwood and J. J. Miller (See Reverse) | | 8. CONTRACT OR GRANT NUMBER(s) |
| 9. PERFORMING ORGANIZATION NAME AND ADDRESS US Army ARDEC Benet Laboratories, SMCAR-CCB-TL Watervliet, NY 12189-4050 | | 10. PROGRAM ELEMENT, PROJECT, TASK AREA & WORK UNIT NUMBERS AMCMS No. 694000084 PRON No. AW6MC00103AW1A |
| 11. CONTROLLING OFFICE NAME AND ADDRESS US Army ARDEC Close Combat Armaments Center Picatinny Arsenal, NJ 07806-5000 | | 12. REPORT DATE January 1988 |

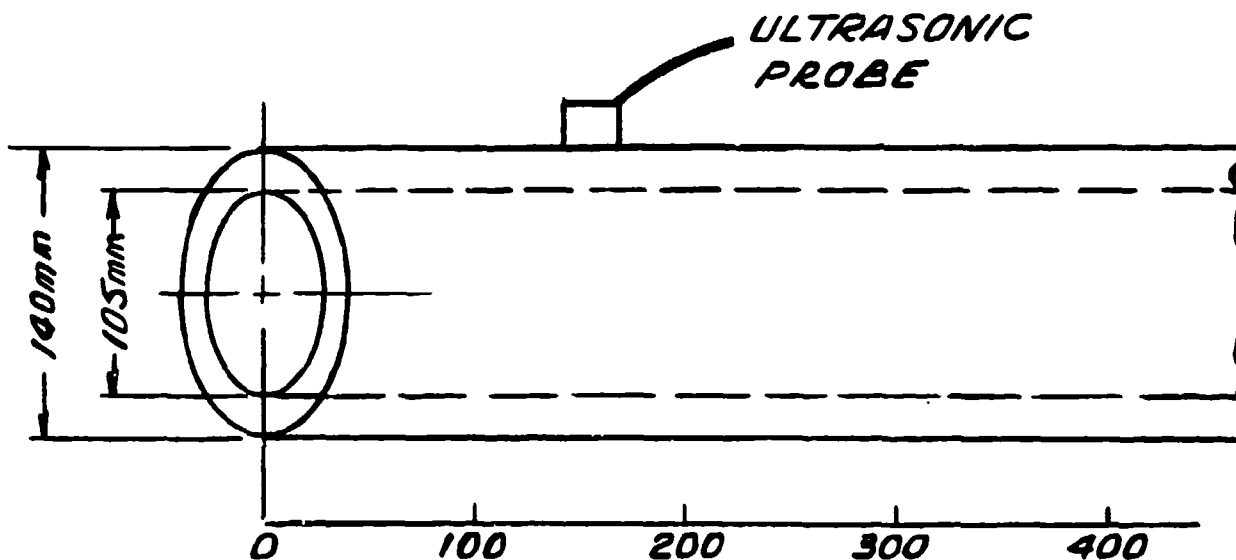
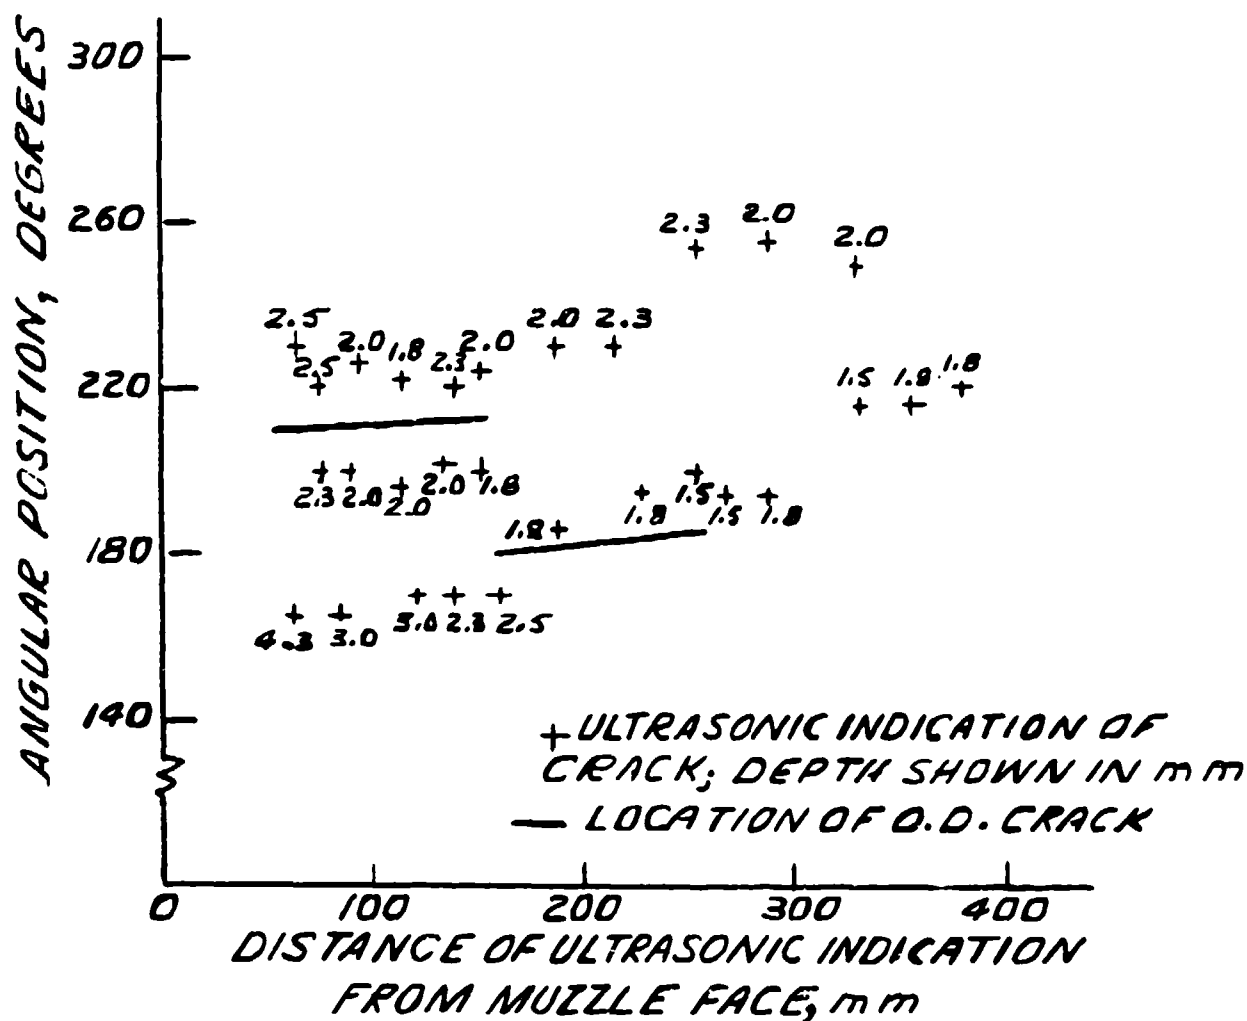
The same general pattern of extensive cracking from the ID and occasional cracks on the OD has been noted in a number of tubes. Table I lists 13 tubes in which muzzle cracking has been noted, along with service and test conditions which apply to these 13 tubes. Groups 1 and 4 are tubes in which cracks were observed with the unaided eye on the OD surface. Groups 2 and 3 are tubes in which cracks were located by ultrasonics with depths partway through from the ID

Figure 1. Ultrasonic measurements of location and depth of muzzle cracks in 105-mm tube #156.

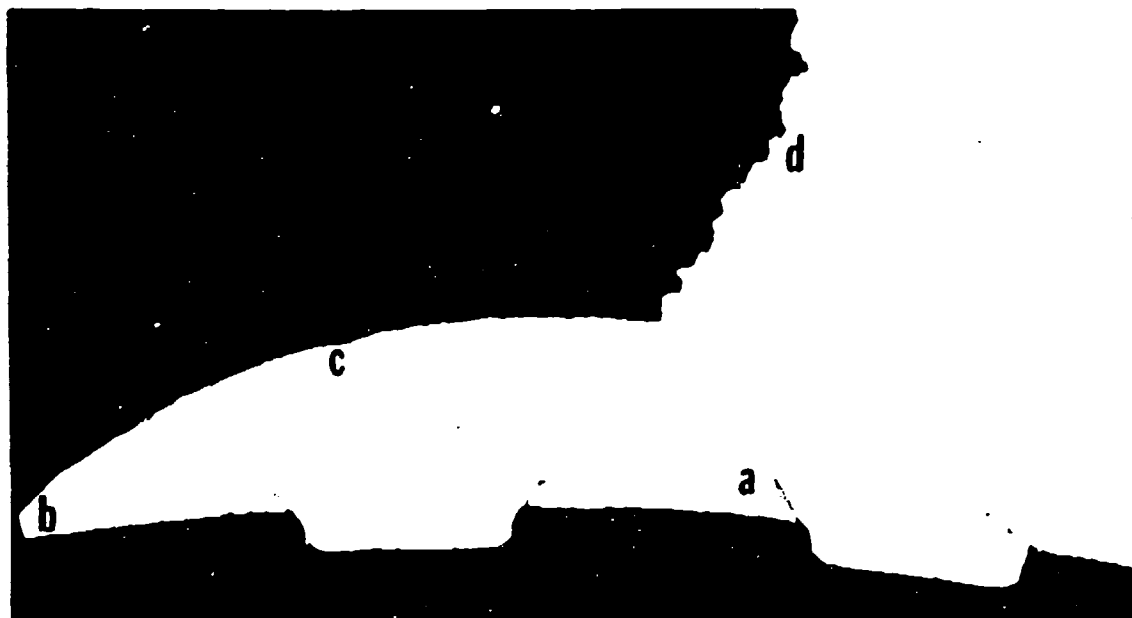
Additional evidence of the unexpected circumferential direction cracking is shown in Figure 3. Initiation of cracking can be seen at each of the rifling land fillets, such as location (a). The crack which eventually grows through to the OD surface starts at location (b), at the fillet of the unseen land to the left. Soon after this primary crack left the ID surface, it began to turn, so that when it reached location (c), its direction was almost directly circumferential. Cracks which have grown at least to the extent of location (c) are very easily located using the end-on ultrasonic method (ref 6), because a crack of this orientation presents a nearly planar surface approximately normal to the ultrasonic beam, and this results in a strong reflection. As the crack grew further, it eventually turned back toward a generally radial direction and

resumed growth toward the OD surface, location (d). Microstructural and fractographic details at these locations are given in the next section.

Figure 3. Polished and etched cross-section of a portion of tube #156 showing crack growth from ID to OD and locations of additional investigation (15X).

tubes were made, this is little more than speculation. The unanticipated area of circumferential direction tensile residual stress also provides an explanation for the puzzling circumferential direction crack growth shown in Figure 3. The circumferential tensile stress caused the stress corrosion cracking predominantly in the radial direction, normal to the stress direction, as expected. However, once the crack had grown through the area of tension, it faced a compressive stress, was forced to turn to the circumferential direction, and continued its growth in response to fatigue loads. The metallographic evidence in Figures 4b and 4c supports this line of reasoning.

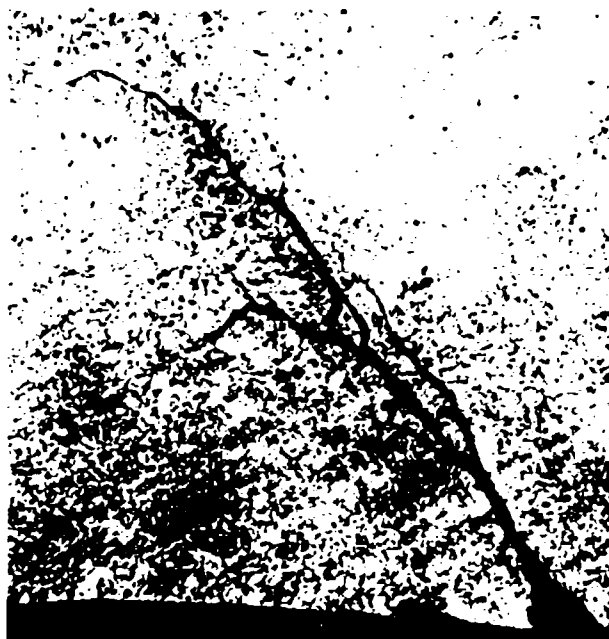
Figure 4 is a series of photomicrographs and fractographs at the locations shown in Figure 3. Figure 4a shows the multiply-branched nature of the cracks which occur at the land fillets, location (a). Figure 4b shows a relatively featureless fracture surface with some indication of secondary cracking at location (b) of the primary crack. These characteristics in Figures 4a and b - multiple branching, featurelessness, and secondary cracking - are all indications of stress corrosion cracking, as opposed to cracking due to mechanical loads, such as fatigue and fast fracture. Farther in the growth of the primary crack shown in Figure 3, evidence of both fatigue and fast fracture was observed. Figure 4c shows typical morphology of fatigue cracking, and Figure 4d shows the dimpled rupture of fast fracture.

- (a) Photomicrograph of location a in Figure 3 showing cracks from the land fillet (100X).
- (b,c,d) SEM fractographs at locations b, c, d in Figure 3 (400X, 100X, 1700X, respectively).

In the case of the muzzle cracking, we believe that the entire early growth of the cracks, such as that shown in Figure 4a, was predominantly stress corrosion cracking. Of the three basic requirements for stress corrosion cracking - a sustained tensile stress, a susceptible material, an aggressive environment - the first and second relate directly to service conditions which were substantially altered from the norm for these tests. We believe that there was an unanticipated area of circumferential direction tensile residual stress within a few millimeters of the ID surface of the tube. The tensile residual stress may have been related somehow to the high-overpressure, hydraulic method used for the autofrettage of these tubes, but so much time has passed since the

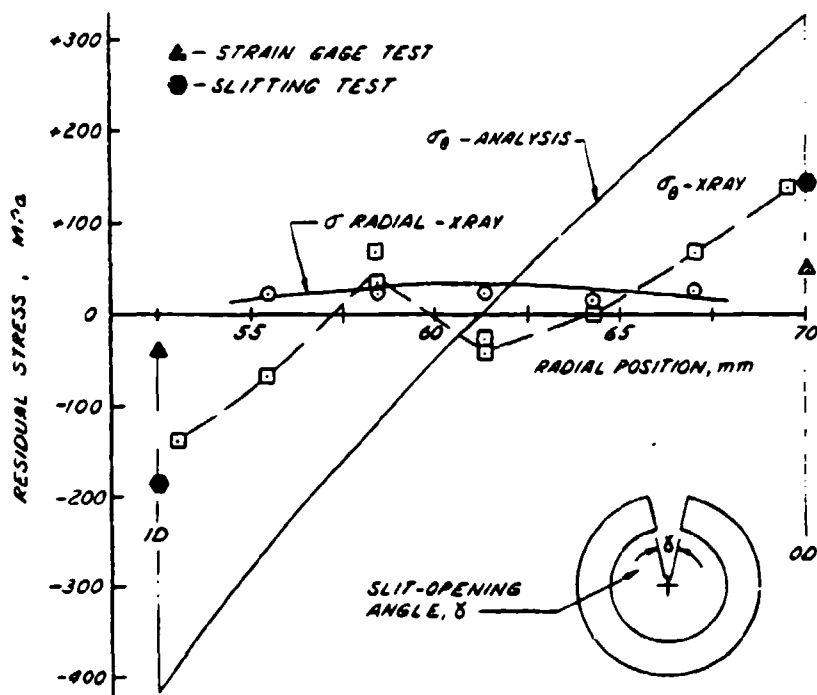
Three independent measurements of residual stress were performed on segments from the muzzle end of tube #190, see Figure 6. The strain gage tests used the simple concept often used to measure residual stress, of cutting away most of the material around a gage which was mounted on the component while it was still whole. The strains relieved from one gage each on the OD and ID surfaces of the tube were used to calculate the stresses at these points. The slitting test used a slice cut from the tube which was slit and measured to determine the angle of opening, γ , see Figure 6. Values of circumferential

Figure 6. Measured and analytical residual stress distributions for 105-mm tube #190.

The third type of measurement of residual stress used for the results in Figure 6 is the well-known x-ray method (ref 9). It is clear that the three sets of measurements are not in close agreement. This is a reflection of the inherent difficulty in measuring residual stress, particularly in a failed component after many years of service. The important point is that the results from the three independent methods all lead to the same basic conclusion, that the measured residual stress in tube #190 is significantly below that expected from analysis. Lower than expected residual stresses can occur for some autofrettage conditions due to the Bauschinger effect (ref 8), which can significantly reduce the yield strength of the high strength steel used for cannon. However, a significant Bauschinger effect has not been observed for an r_2/r_1 as low as 1.33, the value for the tubes considered here.

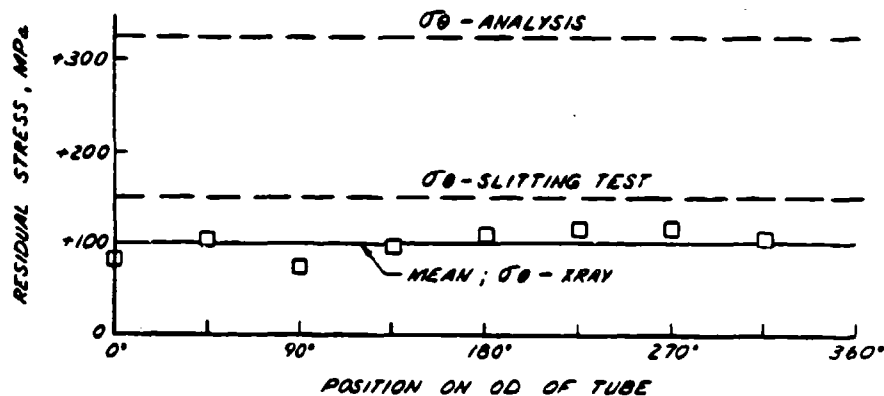
slitting test are considerably below that from analysis. In addition, the x-ray results indicate that whatever caused a reduction in residual stress in this tube did so in an approximately circularly-symmetric manner.

Figure 7. Measured and analytical residual stress for 105-mm tube #866.

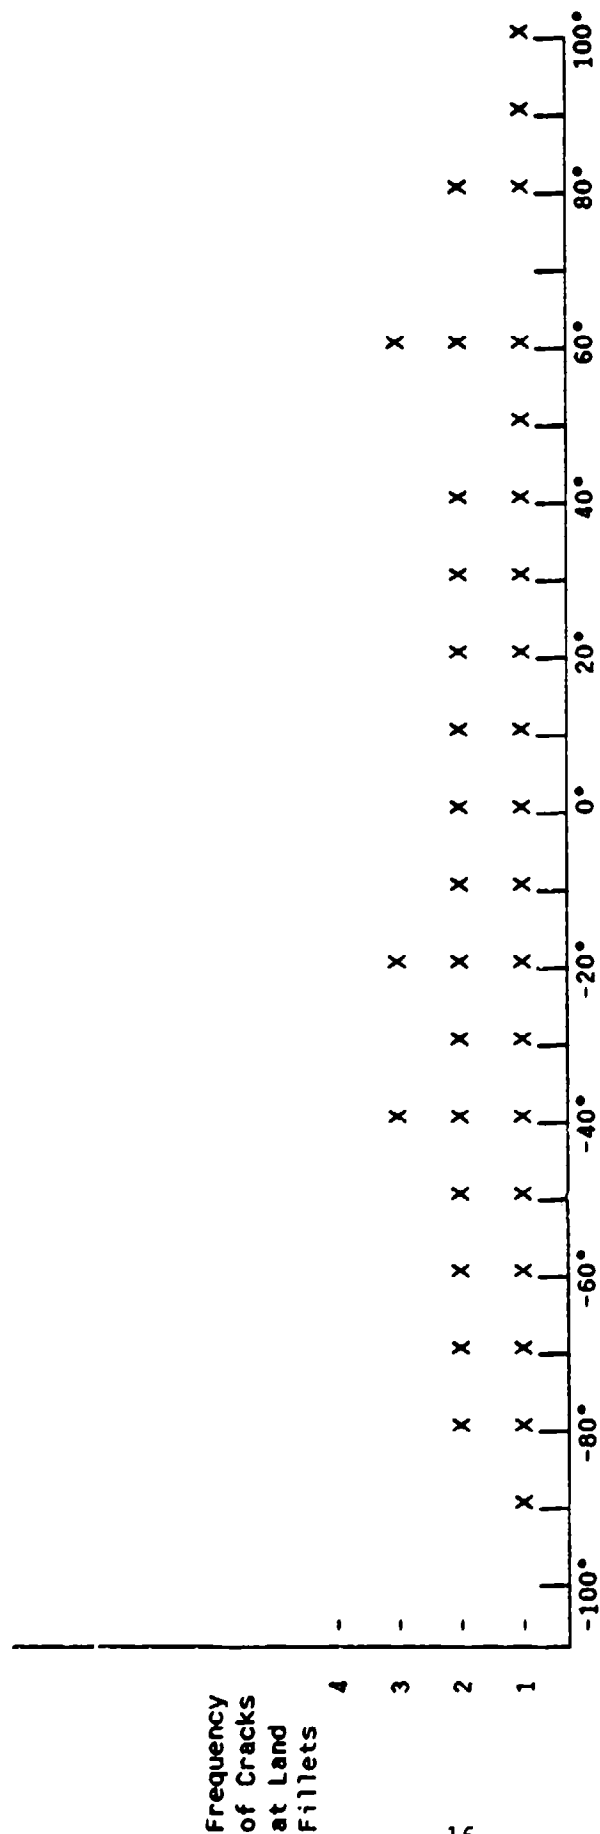
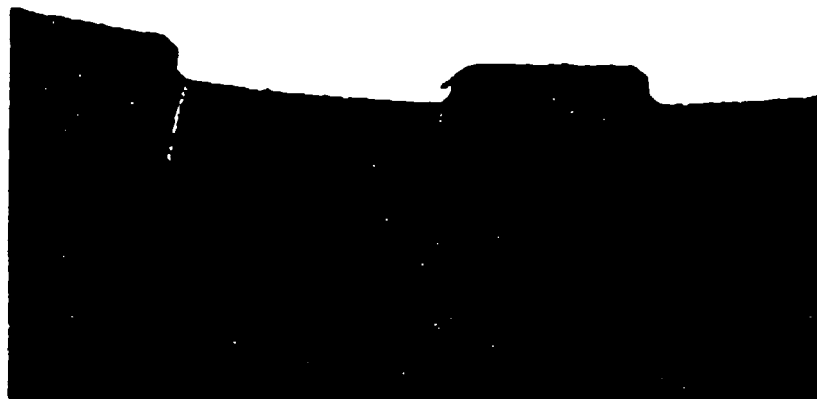
The disks were immersed for 90-minute intervals in an aqueous solution which has become a standard and quite severe environment for stress corrosion cracking testing of high strength steels (ref 10), the "sour" or "sulfide cracking" test solution. It is 3.5 percent NaCl solution plus 0.5 percent acetic acid, periodically saturated with H_2S . Two of the several disks tested showed cracking. Magnetic particle inspection of a disk from tube #372 showed cracks of 0.1 to 0.4-mm length, following one 90-minute immersion. A disk from tube #251 showed many cracks, 37 in total, of 0.1 to 0.8-mm length, following two 90-minute immersions, see Figure 8. Table III shows the frequency and location of occurrence. There is little chance that these cracks had been present before exposure to the test solution, because the same magnetic particle inspection was performed before and after exposure. Also, the nature of the cracking is quite different, as can be seen by comparing Figures 3 and 8. The difference in direction of the cracking shown in the two figures may be due to the presence of applied mechanical loading in service, Figure 3, and only residual stress loading in the laboratory, Figure 8. The important point is that the growth of the cracks upon exposure to the test solution could have occurred only in the presence of a sustained tensile stress, a residual stress in this case.

Figure 8. Macrophotograph of radial cracks in section of 105-mm tube #251 following 90-minute immersion in NBS stress corrosion cracking test solution (7X); ultraviolet illumination following magnetic particle NDT procedure.
